Application of Quality Tools in Solving a Production Problem

Abstract: The article focuses on the issue of automotive products. The product is a component necessary for the proper functioning of the engine in a car. The application of various quality tools represents the identification and subsequent elimination of defects to improve the manufacturing process. The aim was to reduce the proportion of complaints related to product malfunction and to increase the overall control of the manufacturing process. This includes activities such as identification, analysis, and elimination of the root cause of the claimed product function. Standard tools used to identify and analyse the root cause of the problem such as Ishikawa, Pareto, 4Wh1 were used. It usually focuses on inventory reduction, machine optimization, process synchronization. In addition to basic quality tools, process capability or microscopic analyses were also used. The system quality management tool of auditing was also used. The root cause of the problem was identified. Measures were subsequently taken and savings of more than EUR 50,000 were achieved.

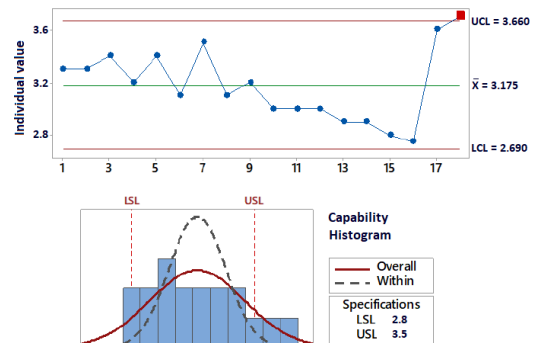
Figure 4: Analysis of measurement results

This is a sampling for the months of May, June, July. As can be seen the air leakage values range from 2.7 to 3.8 cm³/min. The Capability Histogram

(Figure 4, right hand side) shows that this is an incapacitated process. The value of CP and CPK < 1.33 confirms it. The upward jumps in air leakage values are alarming.

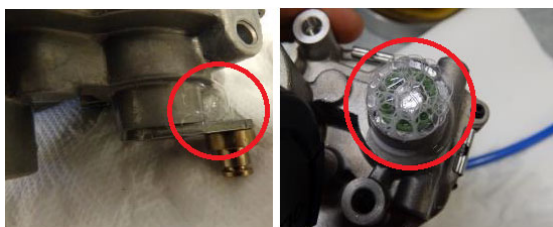
Figure 5: Bubble test result

The figure shows the air leakage points on the actuator. The test confirmed that the air leakage is related to the product (actuator) itself. The air leak is caused by a leak at the junction of the kinematic housing and the output lever. An elementary tool for finding the root cause is the Ishikawa diagram [7,8,9]. Therefore, it was used in the next step.

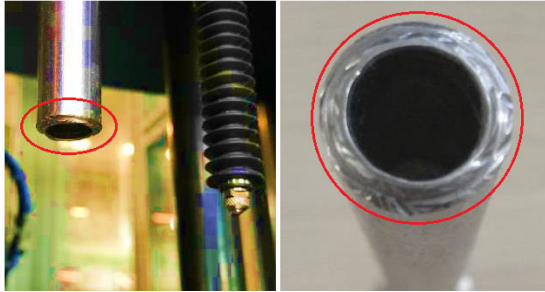
Figure 8 Wear delimiting head

This contamination caused a misalignment at the joint between the housing and the output lever. This had an impact on the leakiness of the product and the air leak itself. This finding initiated an audit at this site. The result of the audit at Workstation B - Automatic Roller Insertion revealed a serious problem. The surface of the delimiting head extension was badly worn (Figure 8). The wear of the delimiting head was occurring faster than expected. The surface of the worn head was causing its worn surface to push off into the roller. The roller thus gained unwanted relief, which caused the leakage of the actuator after it was assembled.

The worn surface of the extension was the root cause of the actuator air leak. The wear occurred because the maintenance interval of this extension was not set appropriately. Thus, rapid wear was not anticipated. Based on this knowledge, the following measures were taken:

- Immediate replacement of a worn-out delimiting head.
- Inclusion of the delimiting head in the list of spare parts of the line with increased frequency of replacement.
- Development of a control action plan for Workstation B (Figure 9).
