Estimation of the Polfix Type Plates Exploitation at Plate Fixation of Femoral Shafts

Abstract: The so-far unsolved issues of the biomechanics of the bone – plate stabiliser system functioning in a multi-plate system constituted the main focus of the performed research. The few available publications treat this issue selectively and often generally. The paper presents a damages problems of the Polfix stabiliser at plates fixation. The surface failure at Polfix stabiliser elements showed typical damages for this system. Damages of screw's stepl heads as well as the surface layers failure of the conical holes on clamping plates and the coned seat on tie plates were observed. The surface failure at a clampig's screws at copressive hole were visible in a lesser degree. The biggest wear areas are visible on the cooperating surfaces of the plate sockets and the bone screw heads. Many types of damage characteristic of processes of corrosion damage and tribological wear, mainly abrasive, adhesive, and fretting wear, are observed here.

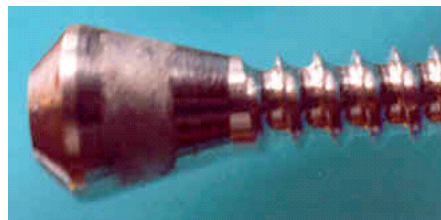
Fig. 1: A sample view of abrasive damage as a result of the so-called fretting.

Research was conducted on a group of randomly selected cases of plate fixation of femoral fractures (Figure 1). Research material was obtained from areas of direct contact with the implant. Samples were tested for existing chemical makeup with the use of a scanning microscope Hitachi S-3000N. The tests were conducted in speeding voltage of 15kV and measure time of 100s. Additional experimental

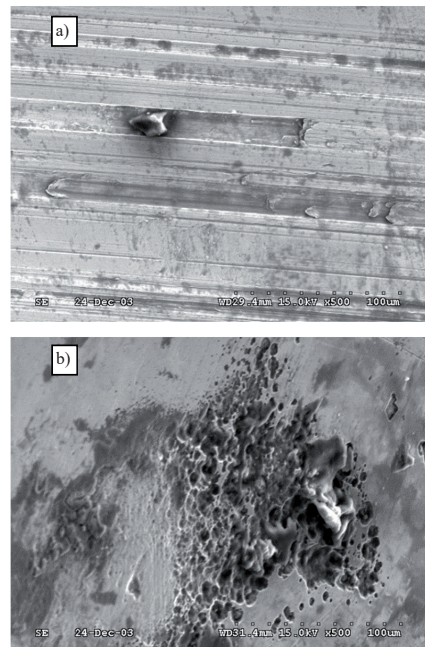
Fig. 3: A two basic types of damage: a) of the first type (a form characteristic to tribological wear), b) of the second type (a form characteristic to corrosion wear).

Figure 3 illustrates a view of abrasive damage as a result of the so-called fretting, caused by interactive

shifting of the bracing plate, the connector, and the screw head. Wear through fretting is a phenomenon of damaging the top layer, consisting in forming of local material loss areas in the elements undergoing vibration or slight contact slip. Wear through fretting accompanies, among others, cooperation of connections of the pin, screw head and rivet type. Products of fretting are particles in the range of $0.01 \div 0.1 \mu\text{m}$, usually. A very significant consequence of fretting, beside abrasive wear products, is indent (pit) formation on the surface. The indents may be small (when the products leave the contact area), or constitute little areas of deep pitting (when the products are not removed). The character of such damage depends on the number of cycles, the amount of wear products, amplitude, load, and humidity (Figure 4).

As a result of the macro- and microscopic observation, two basic types of damage were separated damage of the first and second type. Damage of the first type have a form characteristic to tribological wear; macroscopically, these are marks of friction occurring both on the surfaces of the conical holes in the bracing plates and connector sockets as well as the bone screw heads which cooperate with them. Damage of the second type have a form characteristic to corrosion wear; macroscopically, they are matt places, with some spots of pitting, visible with the naked eye, occurring on the surfaces of the holes in the bracing plates and connector sockets as well as their corresponding bone screw heads.
