# Plasma Nitriding and Its Effect on the Corrosion Resistance of Stainless Steel 1.4006

**Abstract:** The plasma nitriding (PN) technology was applied on the martensitic stainless steel 1.4006. The influence of PN on the corrosion resistance of selected material was investigated. The chemical composition of selected steel was verified using the Q4 TASMAN device. The PN process was performed using two stage nitriding procedure. After plasma cleaning procedure at 515 °C for 45 min in a nitriding atmosphere ratio 20H<sub>2</sub>:2N<sub>2</sub> (l/h) was the first stage nitriding procedure performed at 520°C for 16 hours in a nitriding atmosphere ratio 25H<sub>2</sub>:5N<sub>2</sub> (l/h) and followed by the second stage of nitriding procedure performed at 525°C for 4 hours in a nitriding atmosphere ratio 28H<sub>2</sub>:4N<sub>2</sub> (l/h). The microstructure and mechanical properties of the nitride layers were studied using OES spectrometry, optical microscopy, and hardness testing. The depths of plasma nitride layers were also estimated using a cross-sectional microhardness profiles measurement. The corrosion resistance testing of PN stainless steel 1.4006 samples were carried out

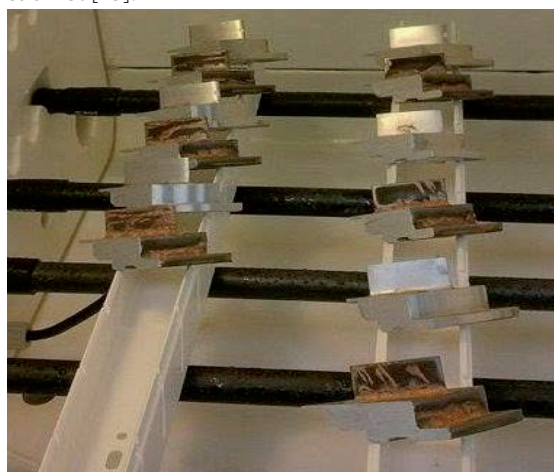
Figure 4: Samples in the corrosion cabinet

The salt spray test, which is a standardized and a popular corrosion test method, was used to evaluate the corrosion resistance of selected experimental samples. The test was carried out according to DIN EN ISO 9227 standard in a SAL 400-FL corrosion cabinet [15].

The SAL 400-FL corrosion test cabinet is designed for carrying out Salt Spray tests according to the DIN EN ISO 9227 (NSS, ESS, CASS) and ASTM B 117-73 standards. It is also possible to conduct the condensation test according to ISO 6270-2 (CH) by operating the cabinet manually [16, 17].

The samples were thoroughly cleaned prior to the insertion into the chamber by technical petrol and an ultrasonic cleaning device. After degreasing, the samples were placed into the corrosion chamber, where the effect of corrosion environment was simulated. The test was carried out at  $35 \pm 2^\circ\text{C}$  in a 5% sodium chloride solution. Sodium chloride was consistent to the ISO 9227 standard. The amount of vapour condensation was set for  $1\text{--}2\text{ ml.h}^{-1}$  at the surface of  $80\text{ cm}^2$  and pH 6.5 to 7.2. The samples were placed by an angle of  $20 \pm 5^\circ$  from the vertical to the plastic supports (Fig 4). The evaluation periods were set according to the ISO 9227 standard recommendations. For a uniform distribution of the observation period, the tested samples were evaluated after 2, 4, 8, 24, 48 and 72 hours. In this experiment the total number of samples was 12. After each tested time, the samples were removed from the corrosion chamber, dried in a vacuum dryer for 20 min at  $45^\circ\text{C}$  and subsequently photographically documented [16, 17].

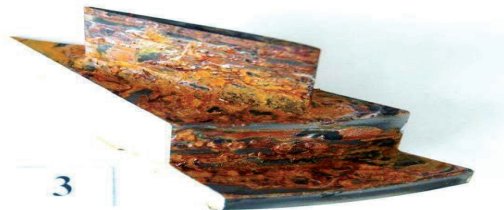
Figure 9: Sample after 8h in NSS

The non-nitrided and PN samples after 8 hours of corrosion test can be seen in Fig. 8 and 9 and samples of final period of corrosion tests, i.e. after 72 hours, are presented in Fig. 10 and 11, respectively.

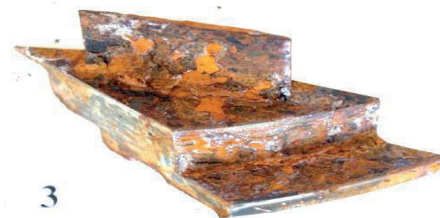
Figure 11: PN sample after 72h in NSS
