Application of Quality Tools in Solving a Production Problem

Abstract: The article focuses on the issue of automotive products. The product is a component necessary for the proper functioning of the engine in a car. The application of various quality tools represents the identification and subsequent elimination of defects to improve the manufacturing process. The aim was to reduce the proportion of complaints related to product malfunction and to increase the overall control of the manufacturing process. This includes activities such as identification, analysis, and elimination of the root cause of the claimed product function. Standard tools used to identify and analyse the root cause of the problem such as Ishikawa, Pareto, 4Wh1 were used. It usually focuses on inventory reduction, machine optimization, process synchronization. In addition to basic quality tools, process capability or microscopic analyses were also used. The system quality management tool of auditing was also used. The root cause of the problem was identified. Measures were subsequently taken and savings of more than EUR 50,000 were achieved.

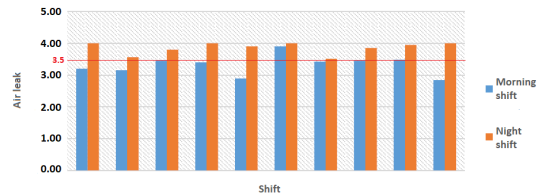
Figure 3: Air leak measurement

When does the problem occur? The control station for the air leak test is fully automated. There is no worker intervention during the measurement. The worker only sets the input parameters of the measurement process. As air leakage was detected in every working shift, the influence of the worker performing the testing can be excluded. A more accurate picture of the occurrence of air leakage detected at the control station is shown in the following figure (Figure 3). The occurrence of exceeding the customer specification (3.5 cm³/min.) relates to both morning and night shifts.

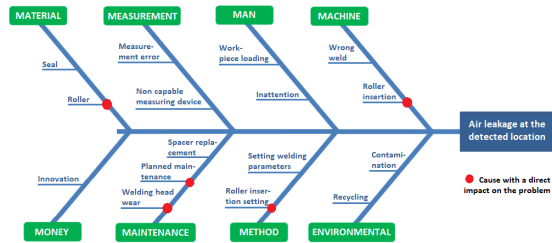
Figure 6: Ishikawa diagram application

By applying the Ishikawa diagram, it was found that the problem can be observed at Workstation B - Automatic Roller Insertion. This workstation is fully automated. The activities of this workstation include insertion of roller and seal. It was therefore necessary to analyse the activities of this workstation. An analysis of the product itself and the location of the air leak detected by the bubble test was performed. A microscope was used to analyse the site in detail. This confirmed contamination with plastic particles (Figure 7).
